INITIAL SITE INVESTIGATION REPORT

SMM REALTY

262 Main Street
Winooski, VT

29 June, 1998

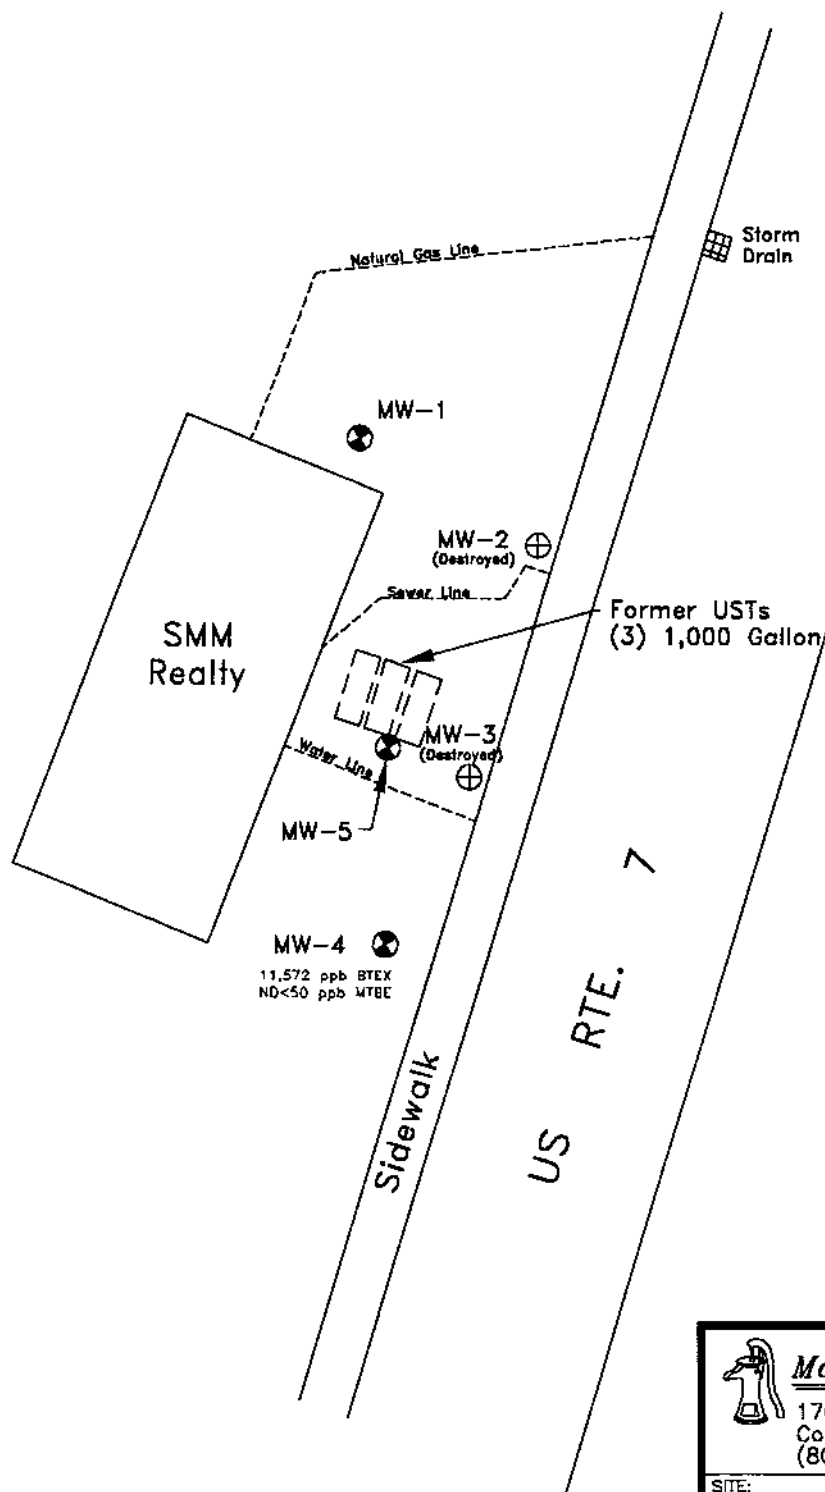
- Adsorbed-phase soil contamination in the vicinity of the former USTs may represent a continuing source of ground-water contamination.
- The Vermont Groundwater Enforcement Standards (VGES) for benzene and ethylbenzene were exceeded in the ground-water sample collected from MW-4, which is located downgradient of the former USTs. Contamination of the principal regulated petroleum compounds benzene, toluene, ethylbenzene, and xylene (BTEX) in this well were similar to those observed during the previous monitoring event in December 1994. Contamination of the gasoline additive methyl-tertiary butyl ether (MTBE) in MW-4 was below the analytical detection limit of 50 parts per billion (ppb), which represents a significant decrease from December 1994, when MTBE was detected at 1,230 ppb.

MW-4
11,572 ppb BTEX
ND < 50 ppb MTBE

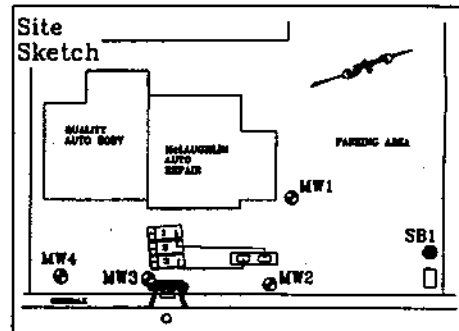
WELL NUMBER MW2

The location of MW-2 is along the east side of the pump island. It was drilled to a depth of 10.3 feet below grade, where auger refusal was encountered. Soils consisted of gravel fill over silty sand to bedrock. Much of the soil samples contained varying degrees of petroleum staining and all of the soil samples contained a strong petroleum odor. Soil screening results ranged from 183 ppm to 1,305 ppm as measured with the PID.

DEPTH IN FEET	WELL CONSTRUCTION	NOTES	BLOWS PER 6" OF SPOON & PID READINGS	DESCRIPTION/SOIL CLASSIFICATION (COLOR, TEXTURE, STRUCTURES)	DEPTH IN FEET
0	ROAD BOX LOCKING WELL CAP			Pavement	0
1	CONCRETE			Brown/gray/white/red GRAVEL FILL with coarse SAND, dry, strong pet. odor.	1
2	SAND/NATIVE BACKFILL		3'-2'- 2,28,21,21 1198 ppm		2
3	BENTONITE		2'-4'- 4,8,4,4 1305 ppm	Hard silty SAND, some staining, dry strong petroleum odor.	3
4	WELL RISER				4
5			4'-6'- 2,1,2,2 997 ppm	Brown stained SILT and SAND with some medium gravel, pet. odor.	5
6	SAND PACK				6
7	WELL SCREEN		6'-8'- 4,3,5,7 183 ppm	7.0' WATER TABLE	7
8				Brown/gray SAND and SILT with gravel, wet, strong petroleum odor.	8
9	BOTTOM CAP		8'-10'- 2,8,5,3 963 ppm	Gray, heavily stained SILT and SAND, saturated, over hard orange CLAY and SILT, medium to strong pet. odor.	9
10			10'-10.3'- 6 blows 110 ppm	Light brown SAND with some silt, saturated, strong petroleum odor.	10
